CASE STUDY

# MONTEREY, CA

## In-Tank THM Removal System Keeps Water System in Compliance

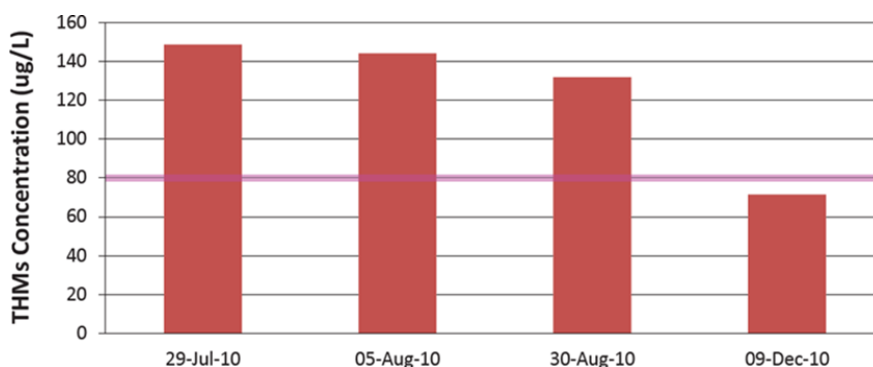
Figure 1. Historic TTHM levels (ppb) per quarter at Ryan Ranch. Locational running annual averages were expected to exceed the Maximum Contaminant Level (MCL) in Q2 2011.

Beginning in 2010, TTHM levels spiked, and the running annual average for the Ryan Ranch system rose dramatically (Figure 1). The dominant THM species was bromoform, "which poses the greatest health risk and is hardest to remove using conventional aeration technologies. Water quality managers calculated that they needed to achieve a TTHM level of less than 50 ppb for the June 2011 measurement for the locational running annual average (LRAA) to remain in compliance. Historical estimates suggested that without a major intervention, TTHM levels were on track to reach 140 ppb by June.

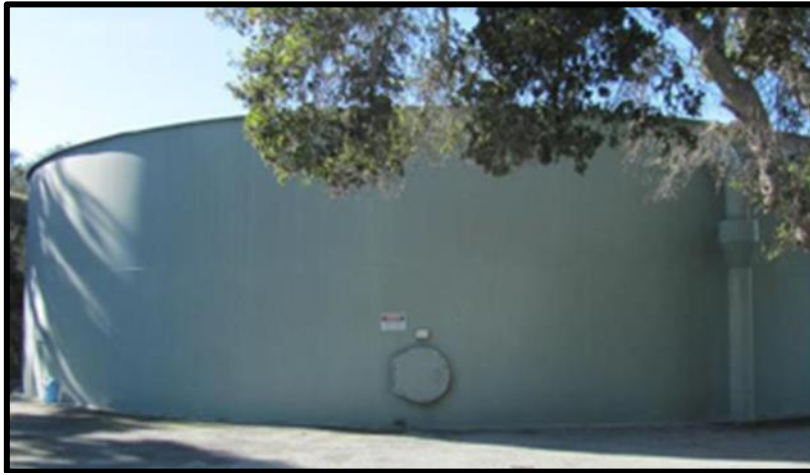
*Figure 2. The Ryan Ranch tank is a 500,000 gallon steel ground storage tank*

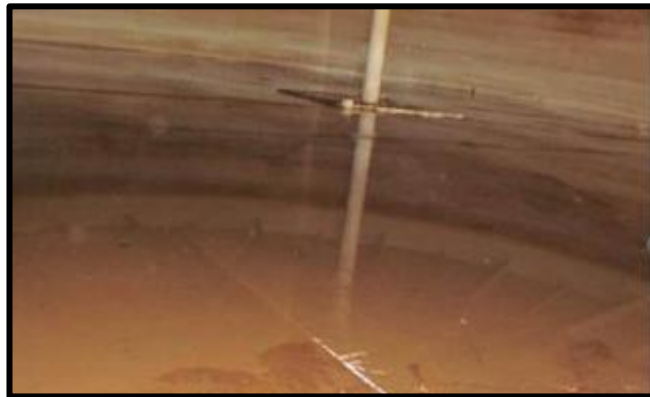
The precise cause of the dramatic increase in TTHMs in the Ryan Ranch tank were uncertain, but several factors likely contributed to the problem:

1. The combination of high temperatures and low turnover likely led to thermal stratification during some months of the year. Thermal stratification leads to high water age and high rates of residual consumption – both of which can elevate THM levels.
2. The use of source water with high bromine levels likely stimulated the formation of brominated THM species such as bromoform.
3. The tank had been periodically washed out, but it had not been chemically cleaned to remove biofilms. The presence of biofilms and sediment provide additional organic matter that can react with disinfectant to produce DBPs.

*Figure 3. Interior conditions of the Ryan Ranch tank prior to TRS.*

PAX Water Technologies, in partnership with Utility Service Company, proposed a multi-staged approach, using a combination of energy-efficient aeration and mixing, combined with a thorough clean-out of sediment and chemical cleaning of the tank interior. The total system was designed to use less than 30 amps at 120V – and leave power to spare for other systems. The combination of power constraints and the high goal for THM reduction (~60 percent reduction) left no room for error.

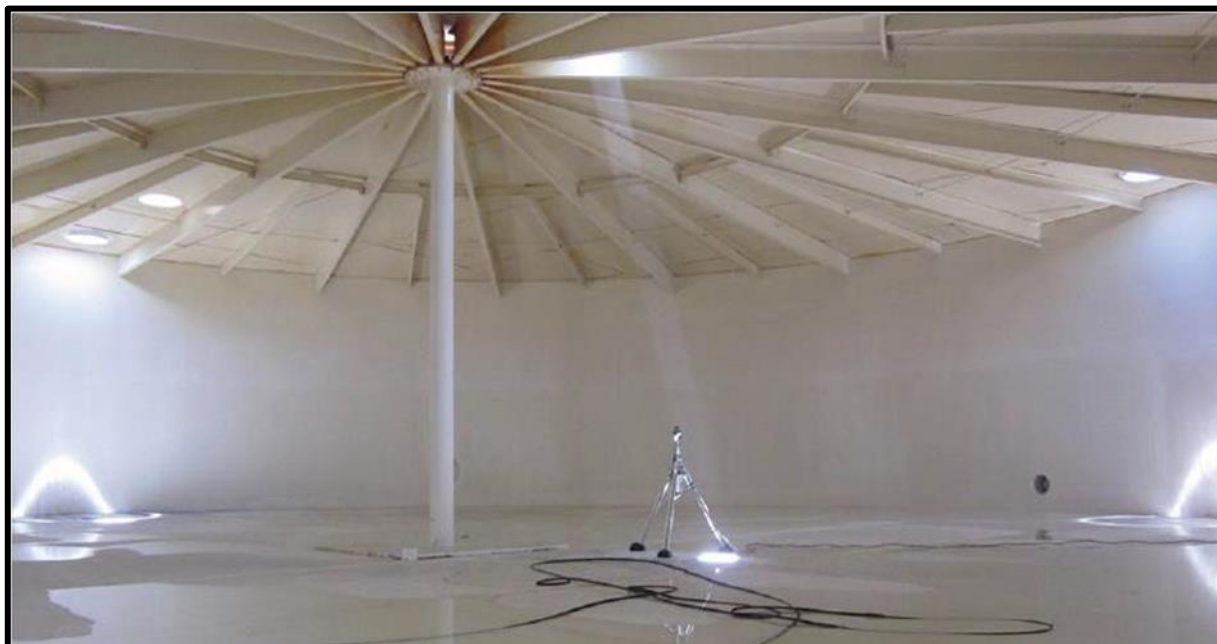
Figure 4. Interior conditions in the Ryan Ranch after cleanout and installation of the PAX mixer.

Installation and start-up was completed on June 23rd, 2011, just 5 days before the Q2 compliance sample was to be taken. Figure 4 shows the results of the chemical clean and installation of the PAX mixer.

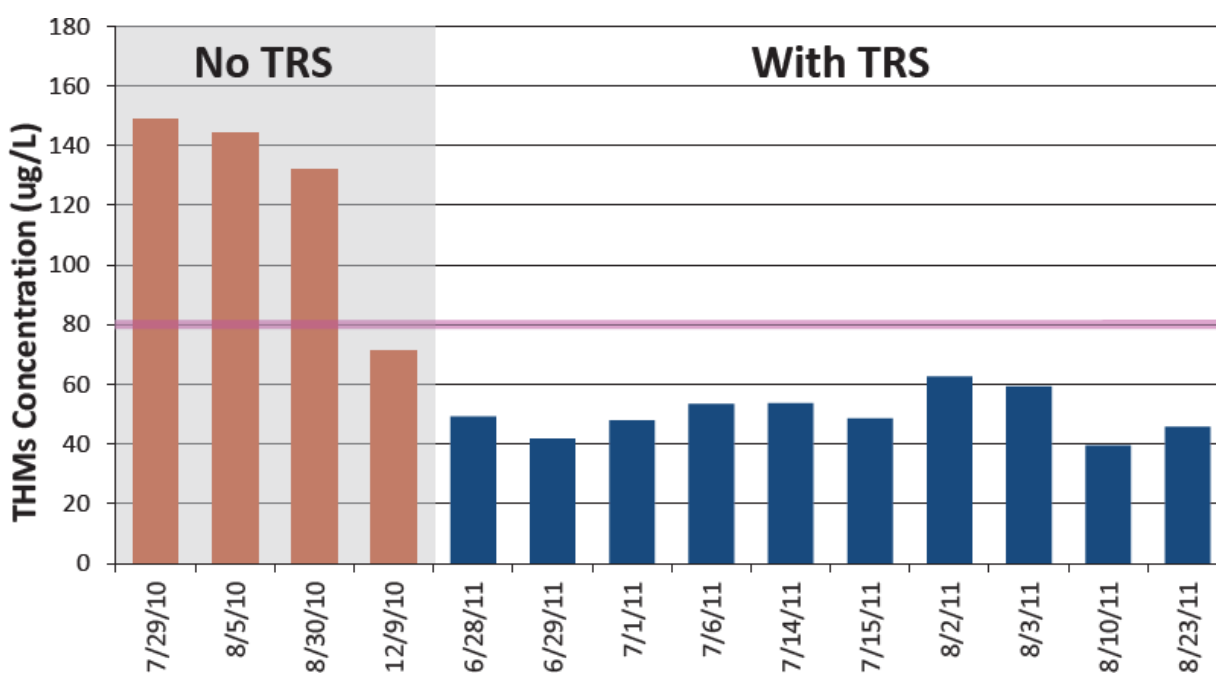
Figure 5. TTHM levels at the Ryan Ranch tank in 2010 (without TRS) and 2011 (after installation of the TRS).

On July 11, the staff at Monterey received their results: TTHM levels were measured at 49.2 ppb (~65 percent reduction), which brought their LRAA to just below the Maximum Contaminant Level (MCL). "This result was HUGE", according to Monterey water quality superintendent Leslie Jordan. Subsequent measurements have shown that TTHM levels have remained under control (Figure 5).
