City of Havre, Montana Successfully Utilizes Mechanical Tank Mixing to Prevent Ice Formation and Improve Water Quality

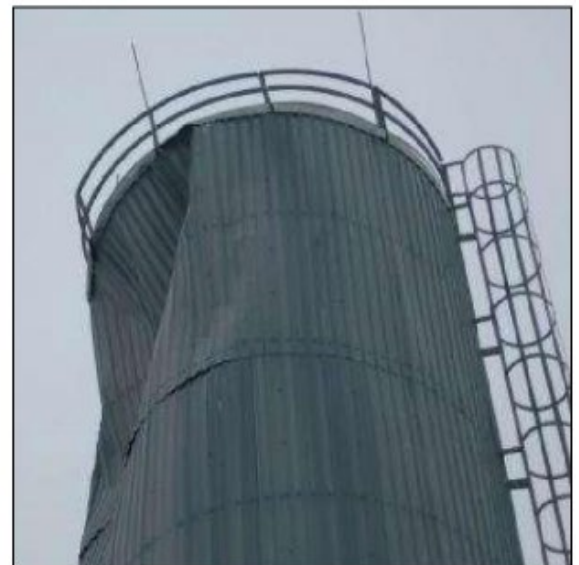
Winter ice formation can damage water tanks

Curiously, in frigid winter conditions, the situation is reversed with the warmer water staying near the bottom of the tank and the coldest water near the top. This is why fish can live through winter at the bottom of a pond without freezing solid. Ice being significantly less dense than liquid water forms at the top of a tank in the winter. Ice “shelves” can break loose as a tank is pumped down and create extensive damage to corrosion protection coatings and internal structures. The City of Havre realized that adding simple mechanical mixing to their newly refurbished 3.5 MG West Water Tank would solve both the potential summer water quality and winter asset protection issues. In 2017, the City added a PAX PWM 400 tank mixer to the West Water tank. The 0.5 HP PAX mixer was sized to ensure the entire tank volume would be fully mixed (over six tank turnovers per day) with temperature convergence throughout the tank to 0.9°F (0.50°C)
