City of Havre, Montana Successfully Utilizes Mechanical Tank Mixing to Prevent Ice Formation and Improve Water Quality

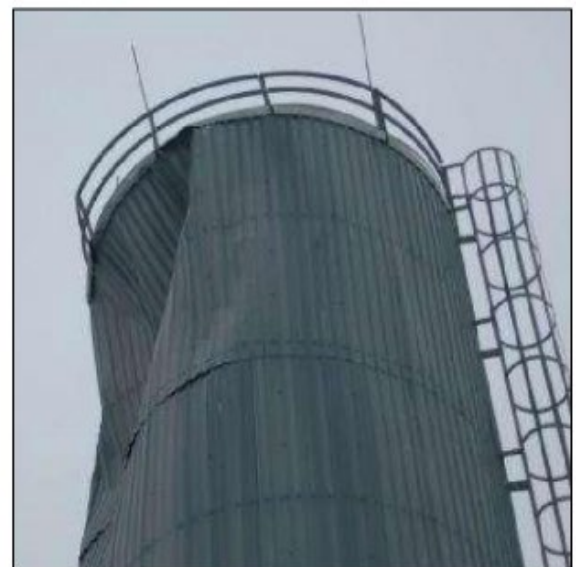
Winter ice formation can damage water tanks

Curiously, in frigid winter conditions, the situation is reversed with the warmer water staying near the bottom of the tank and the coldest water near the top. This is why fish can live through winter at the bottom of a pond without freezing solid. Ice being significantly less dense than liquid water forms at the top of a tank in the winter. Ice “shelves” can break loose as a tank is pumped down and create extensive damage to corrosion protection coatings and internal structures. The City of Havre realized that adding simple mechanical mixing to their newly refurbished 3.5 MG West Water Tank would solve both the potential summer water quality and winter asset protection issues. In 2017, the City added a PAX PWM 400 tank mixer to the West Water tank. The 0.5 HP PAX mixer was sized to ensure the entire tank volume would be fully mixed (over six tank turnovers per day) with temperature convergence throughout the tank to 0.9°F (0.50°C)

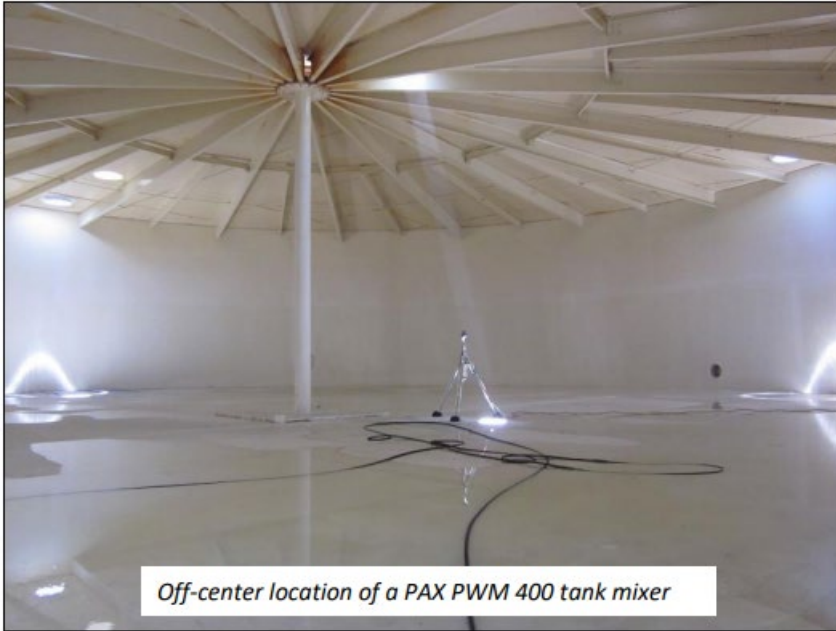
Off-center location of a PAX PWM 400 tank mixer

The PAX Mixer™ system passed the first winter test in 2018 with flying colors. The PAX PWM 400 mixer prevented ice formation in the tank by helping to distribute the incoming warmer water throughout the tank and protecting the City's investment in the tank's refurbishment.
