PINELLAS COUNTY

Thermally Homogenous but Chemically Stratified: Active Mixing Achieves Uniform Residual Levels in 5 MG Concrete Tank

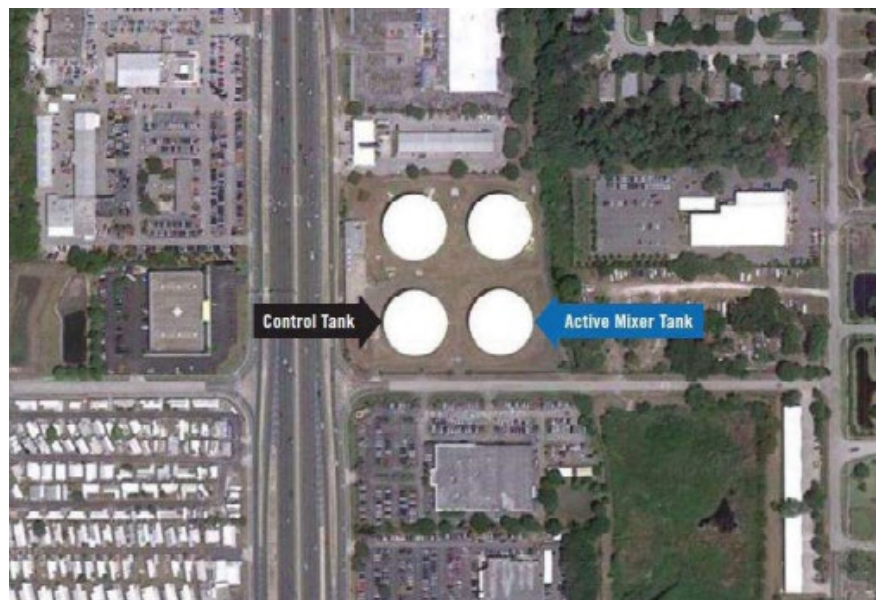
Figure 1. Two 5 MG tanks at the North Booster Pump Station were used to evaluate the effectiveness of active mixing to eliminate chemical stratification. The tank on the bottom left was used as a control, while the tank on the bottom right was used to test the active mixing system.

In order to confirm that active mixing would be sufficient to overcome the chemical stratification inside the tanks, Pinellas County DEI conducted a performance trial in which temperature and residual would be monitored. Two 5 MG tanks at the North Booster Pump Station were selected (Figure 1). A PAX Mixer (PWM400) was installed in one tank and the other tank was left as a control (Figure 2). Both tanks were filled and drained only from their outlet sumps - simulating worst-case hydraulic conditions inside the tanks.

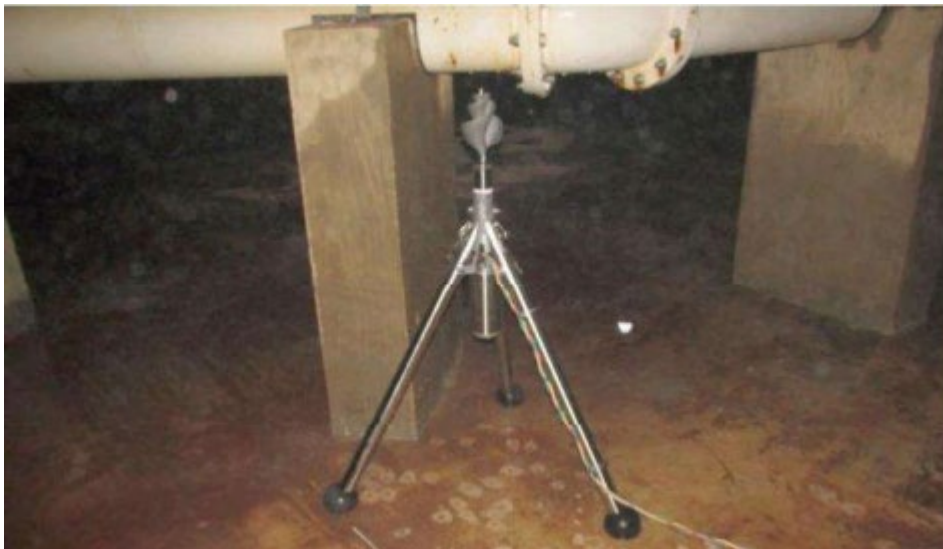
Figure 2. The PAX Mixer was installed in a 5MG tank with an existing passive mixer (shown behind PAX Mixer in above image).

Temperature probes were installed and grab samples were taken from the bottom, middle and top of each tank every day over a 1-week period. Initially, when the PAX Mixer was installed, power was inadvertently set to only 50% of its total power rating.
