CASE STUDY

RL Sherard WTP, Cheyenne, WY

Integrity Municipal Services Successfully Reconditions Emergency Chlorine Vapor Scrubber

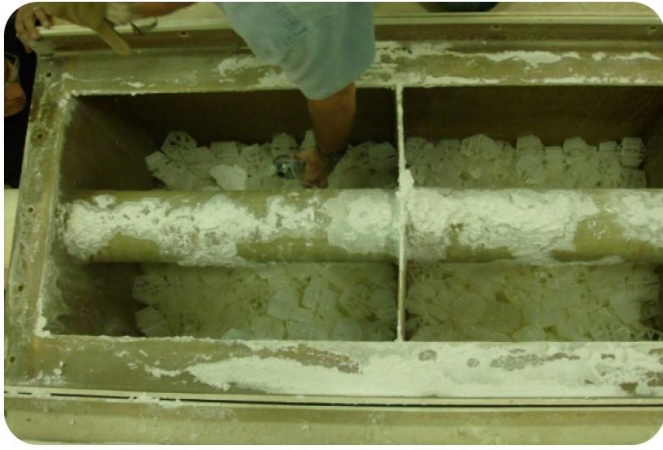
BEFORE ACID WASH

Packing in Second Stage

After the site visit, IMS determined that it could neutralize the spent caustic and acid wash solutions that would be generated from the cleaning process on-site in the nearby sludge holding pond, where a pH in the range of 6-9 was acceptable. Utilizing onsite disposal instead of traditional removal and disposal at qualified facilities provided substantial savings for BOPU. In November 2011, IMS personnel performed the acid wash of the system. The cleaning process included: (1) removing as much of the existing liquid caustic solution as possible from the scrubber sump, neutralizing and disposing of it onsite, (2) dissolving solids buildup in the sump with muriatic acid, (3) recirculating acidic solution over the packing media to dissolve solids buildup and increase pH, (4) cleaning the spray nozzles, and finally, (5) removing the acidic solution from the sump, neutralizing and disposing of it. The system was thoroughly rinsed with water prior to the final inspection of all components.

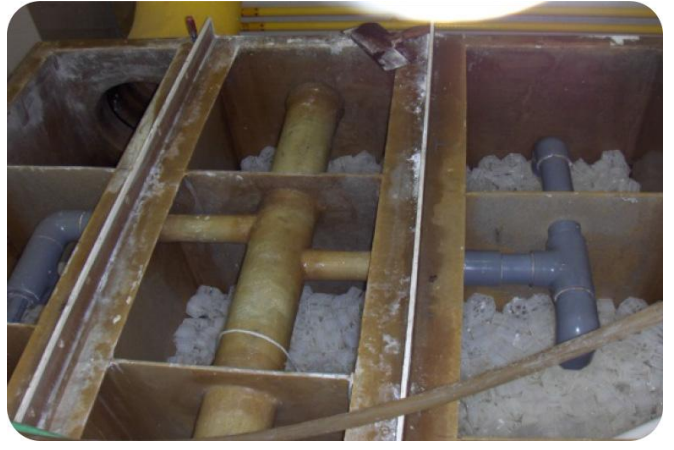
AFTER ACID WASH

Packing After Acid Wash

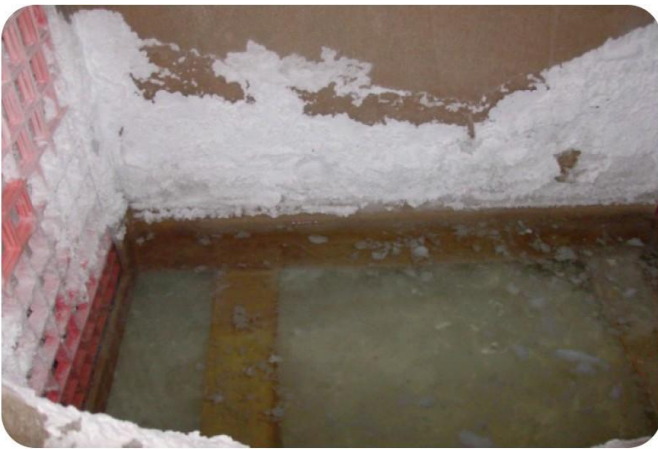
Solids in Sump Up to 29" Thick

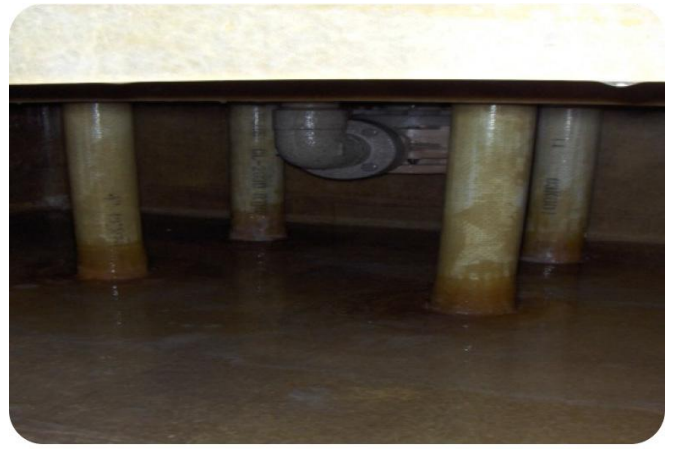
Sump After Acid Wash

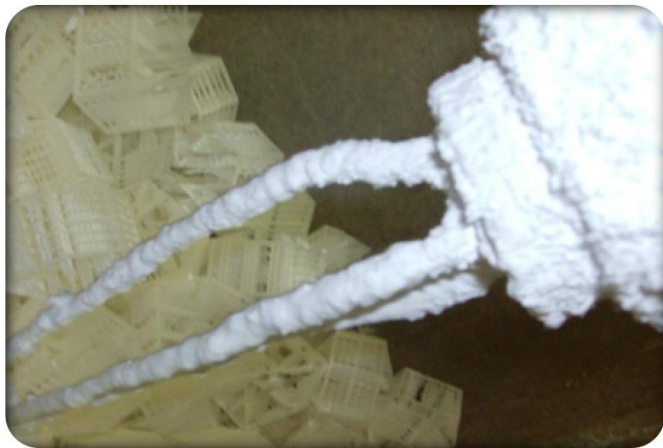
Nozzle in Second Stage

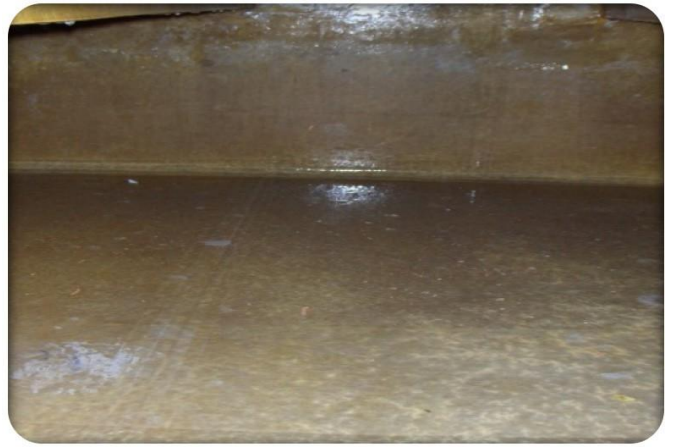
Sump after Acid Wash
