CASE STUDY

Eastern Municipal Water District, CA

Integrity Municipal Systems Successfully Restores Four Bulk Emergency Chlorine Vapor Scrubber Systems

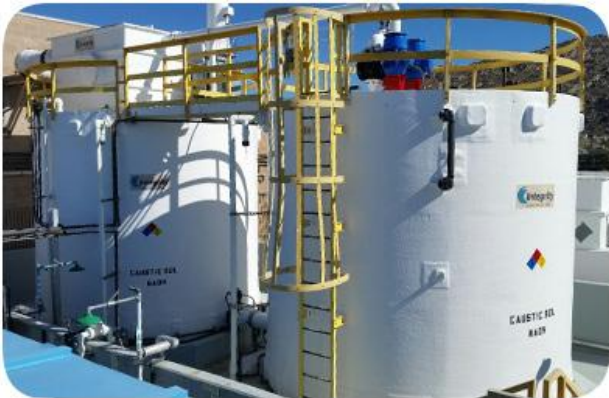
Moreno Valley

EMWD Bulk Emergency Chlorine Vapor Scrubber Systems After Restoration

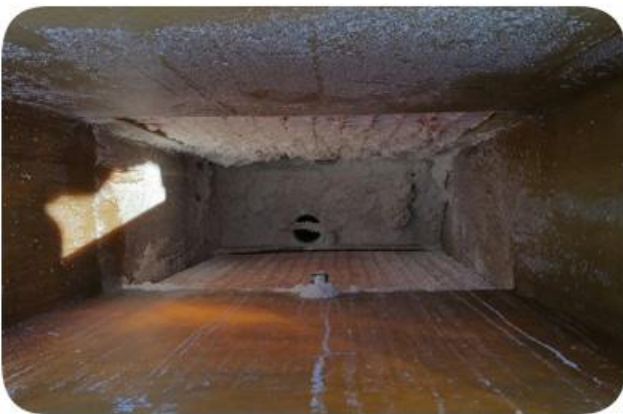
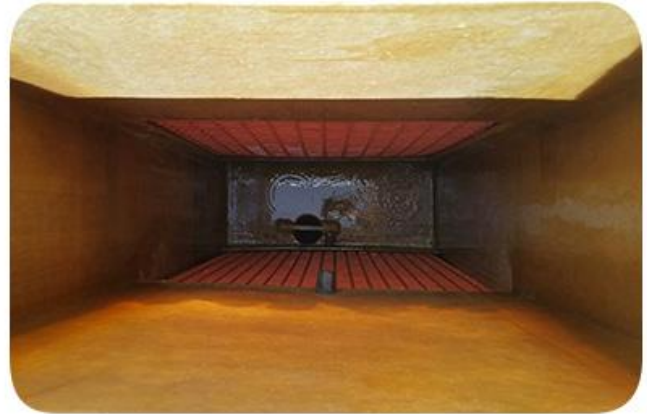
Before

After

Temecula Valley Scrubber Interior Before/After Acid Wash

Each system was drained, acid washed, and wiped clean. Each of the fiberglass-reinforced plastic (FRP) storage tanks and scrubbers was then thoroughly inspected by independent FRP engineers and the FRP manufacturer. Following each inspection, a status report with recommendations for repair was submitted to EMWD's engineers, Erik Jorgenson, P.E., and Gabriel Buenagua, P.E., for review and approval.

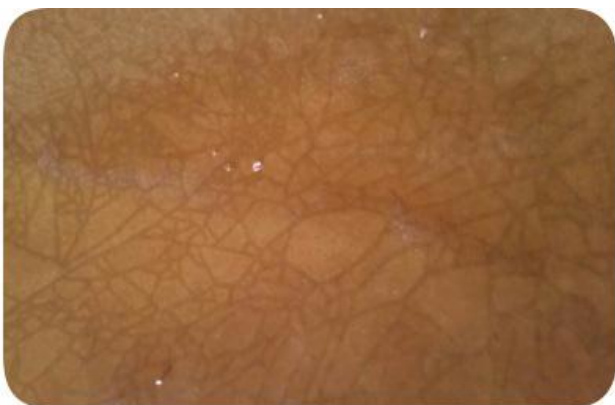
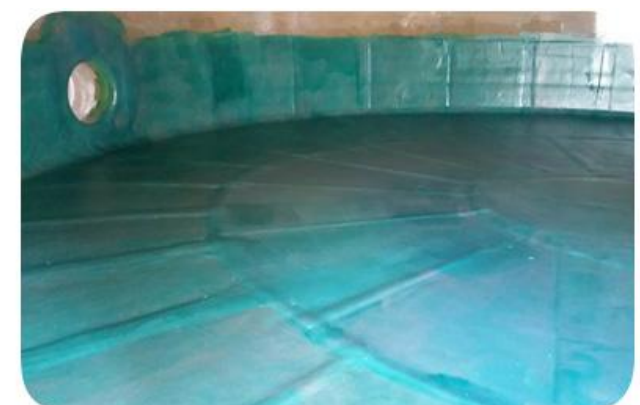
Moreno Valley Scrubber – Before/After FRP Tank Interior Refurbishment

FRP repairs included grinding and relining areas showing signs of chemical attack to the corrosion liner or secondary laminates, and double-coating repaired areas with hot resin and wax coating. Stress fractures were discovered in the north caustic storage tank at the Moreno Valley Regional WRF extending over the entire bottom of the tank. IMS removed the stress fractures and laminated a new structural bottom for the tank. IMS also installed a new 100 mil liner in the bottom of the Moreno Valley Regional WRF south tank.
