CASE STUDY

# Manitoba Water Services

**PAX TRS™ THM Removal System Successfully Removes Over 65% of Trihalomethane (THM) Species in Water Storage Tank at the End of 60-Mile Transmission Line**

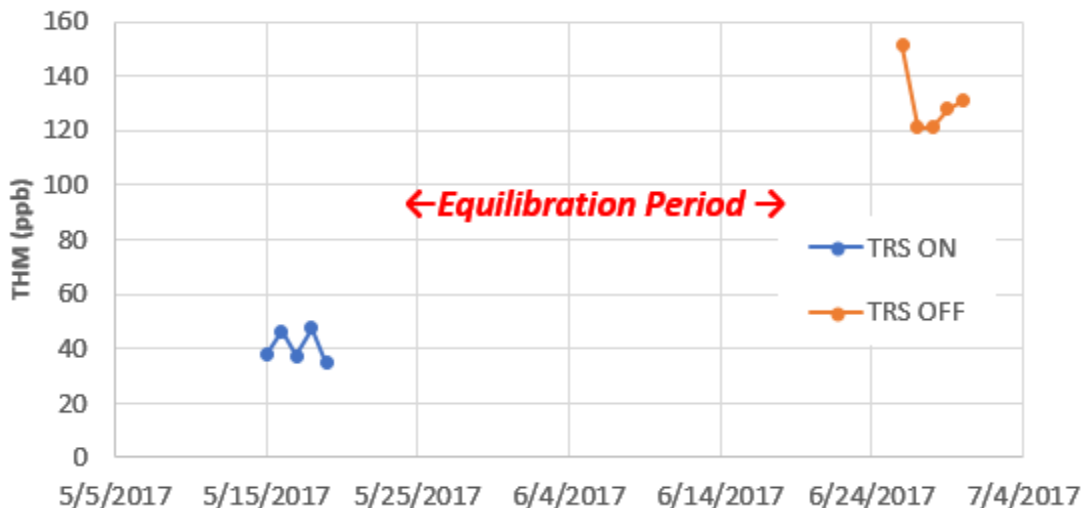
**Summer period illustrating 69% THM removal rates in Plumas Tank**

After three days of installation and commissioning, the PAX TRS™ unit started-up and delivered results. The installation validation data shown in the graph shows that the system is delivering 69% reduction in TTHMs.
