CASE STUDY

Oglala Sioux Rural Water Supply System, Ft. Pierre, SD

Integrity Municipal Services Successfully Reconditions 15-Year-Old Emergency Chlorine Vapor Scrubber System

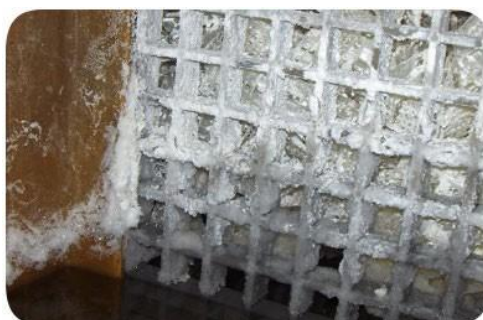
Packed Bed Before Acid Wash

1. Removal of spent caustic;
2. Addition of muriatic acid to breakdown and neutralize solids;
3. Running the recirculation pump to circulate acidic solution through the system in order to wash the scrubber packing media and liquid distribution piping;
4. Removal, cleaning, and reinstallation of spray nozzles; and
5. Removal, neutralization, and rinsing of all internals with fresh water.

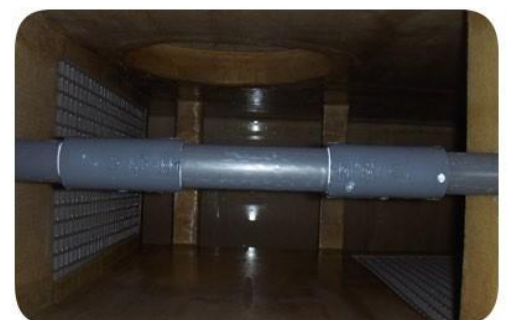
Packed Bed After Acid Wash

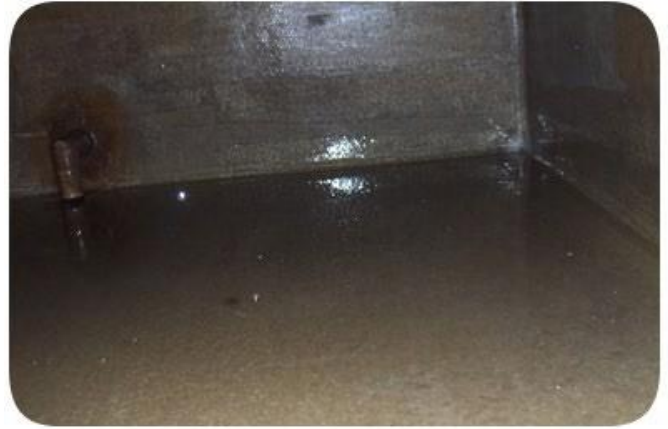
Solids Sump After Acid Wash

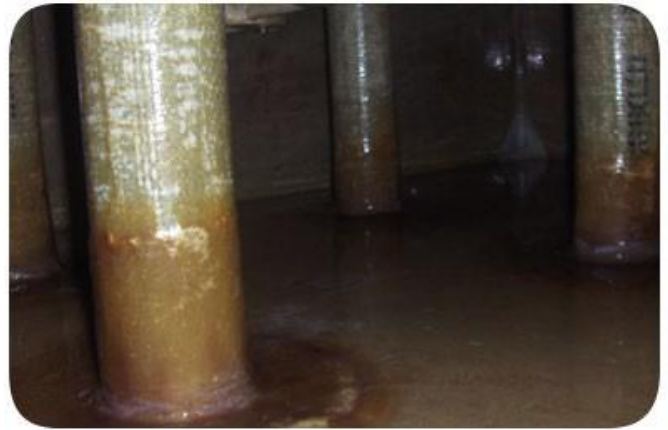
Sump After Acid Wash
